Invitation to Bid HNS 20- 42

Project Address: 2431 Booker Ave TLC, LEAD, HH	
Bid Walk: March 10, 2022 12:30 PM	
Bid Opening: March 17, 2022 2 pm	
Client Name:	Contact Number:
Project Manager:	Contact Number:

Work Specification

Address:	2431 Booker Ave Charlotte, NC 28216	Owner:	Jarrica Kirkpatrick
Structure Type:	Single Unit	Owner Phone:	(704) 309-7344
Square Feet:	947	Program(s):	Tested- HAS LEAD Targeted WH LeadSafe 2019 Healthy Homes LBP 2019
Year Built:	1928		
Property Value:	75900		
Tax Parcel:	06906711		
Census Tract:			
Property Zone:

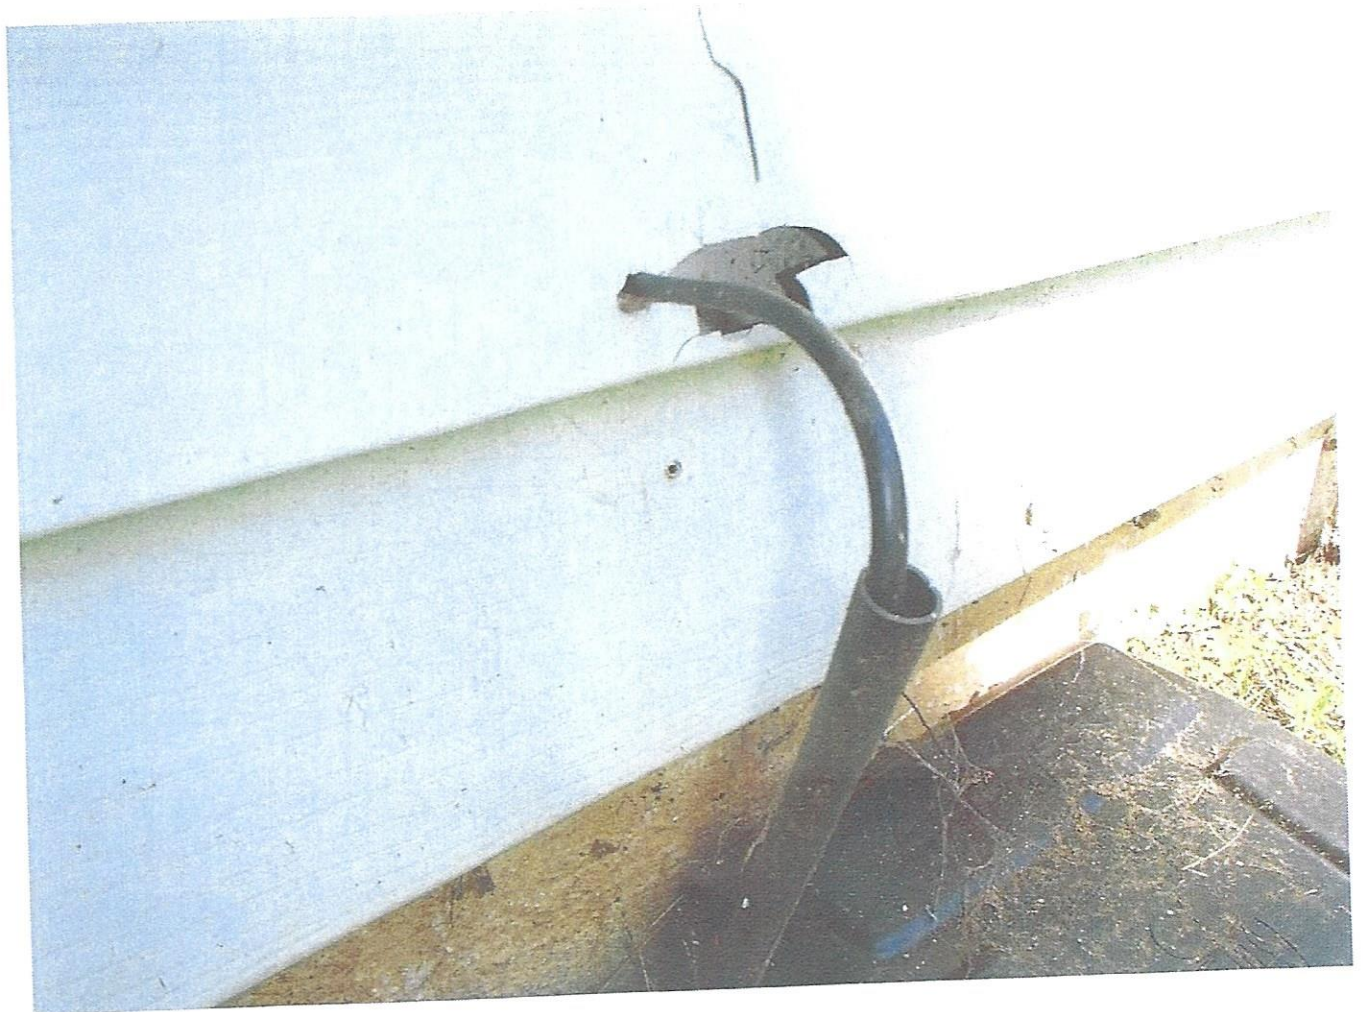
Photo 6 – Exposed Wood Siding – Side C
